**Report of Dr. Brenton Cox
Regarding the May 31, 2017
Explosion at Didion Milling in
Cambria, Wisconsin**

March 31, 2023

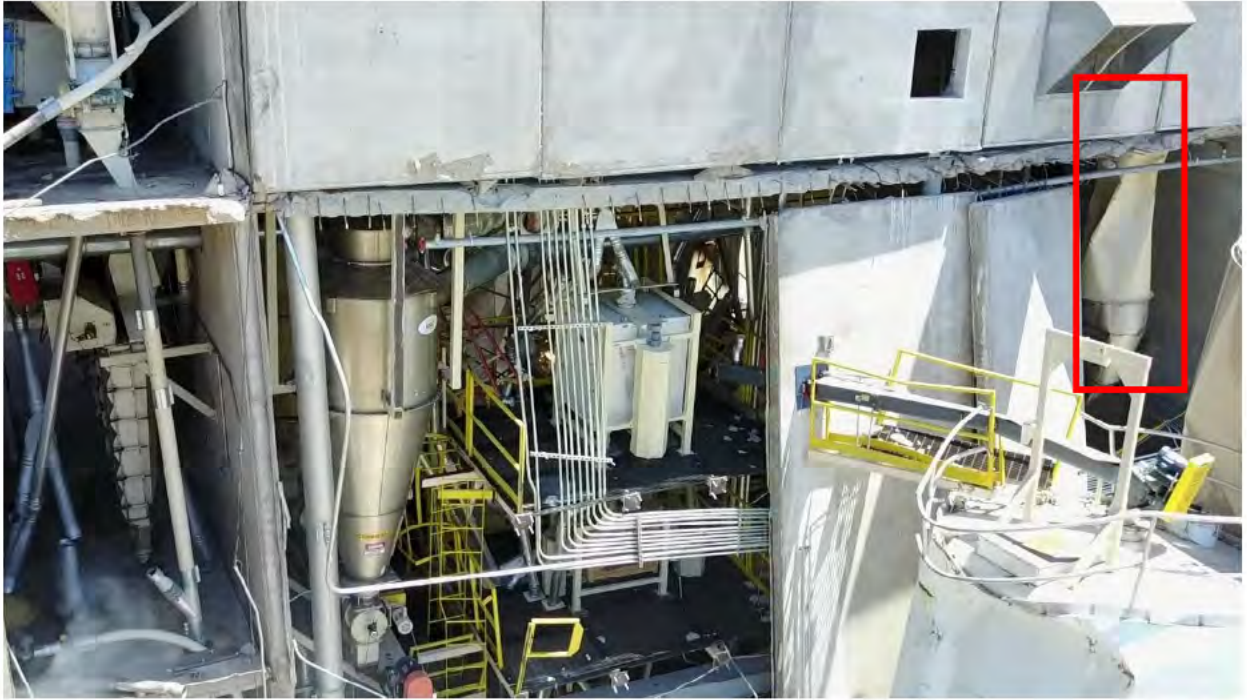
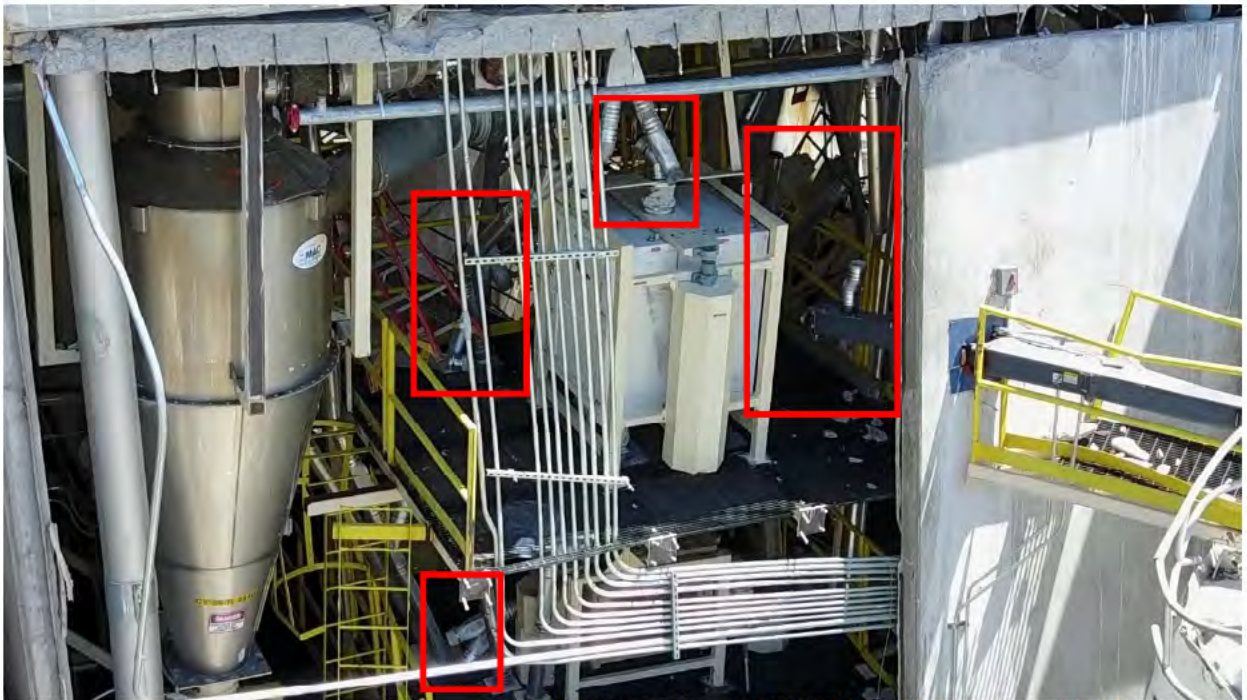
06/15/17 Drone Footage (DJI_0002 MOV). DJI_0002 - frame at 5m52s DJI_0002 - frame at 6m8s

Drone footage from the D-Mill showed separated ducts in Figure 74 (described above in Section 3.3.2 with material ejected into the D-Mill). Additional drone footage from outside of the D-Mill captured other ducting and equipment. From Figure 85, internal overpressure is observed due to caps blown off ducting attached to equipment and collapsed ducting (described in more detail in Section 3.4.2.3.1). The Dry Grit Filter ducts are connected to multiple pieces of equipment in the D-Mill including D1 but no drone footage or photographs inside were captured due to the inaccessibility of location and building stability concerns, respectively.

Figure 85. Post-incident aerial view of D1 equipment showing internal overpressure.

From Figure 85, multiple disconnected ducts are observed. In the top screenshot from drone footage, a collapsed duct can be seen, which is a phenomenon associated with the vacuum pressure that follows an internal deflagration.²⁰¹ In addition to the equipment throughout the D-Mill, ducting from the Dry Grit Filter to the other areas of the mill can be observed on top of the D-Mill connected to the D-Mill Bran Cyclone and fan in Figure 86.

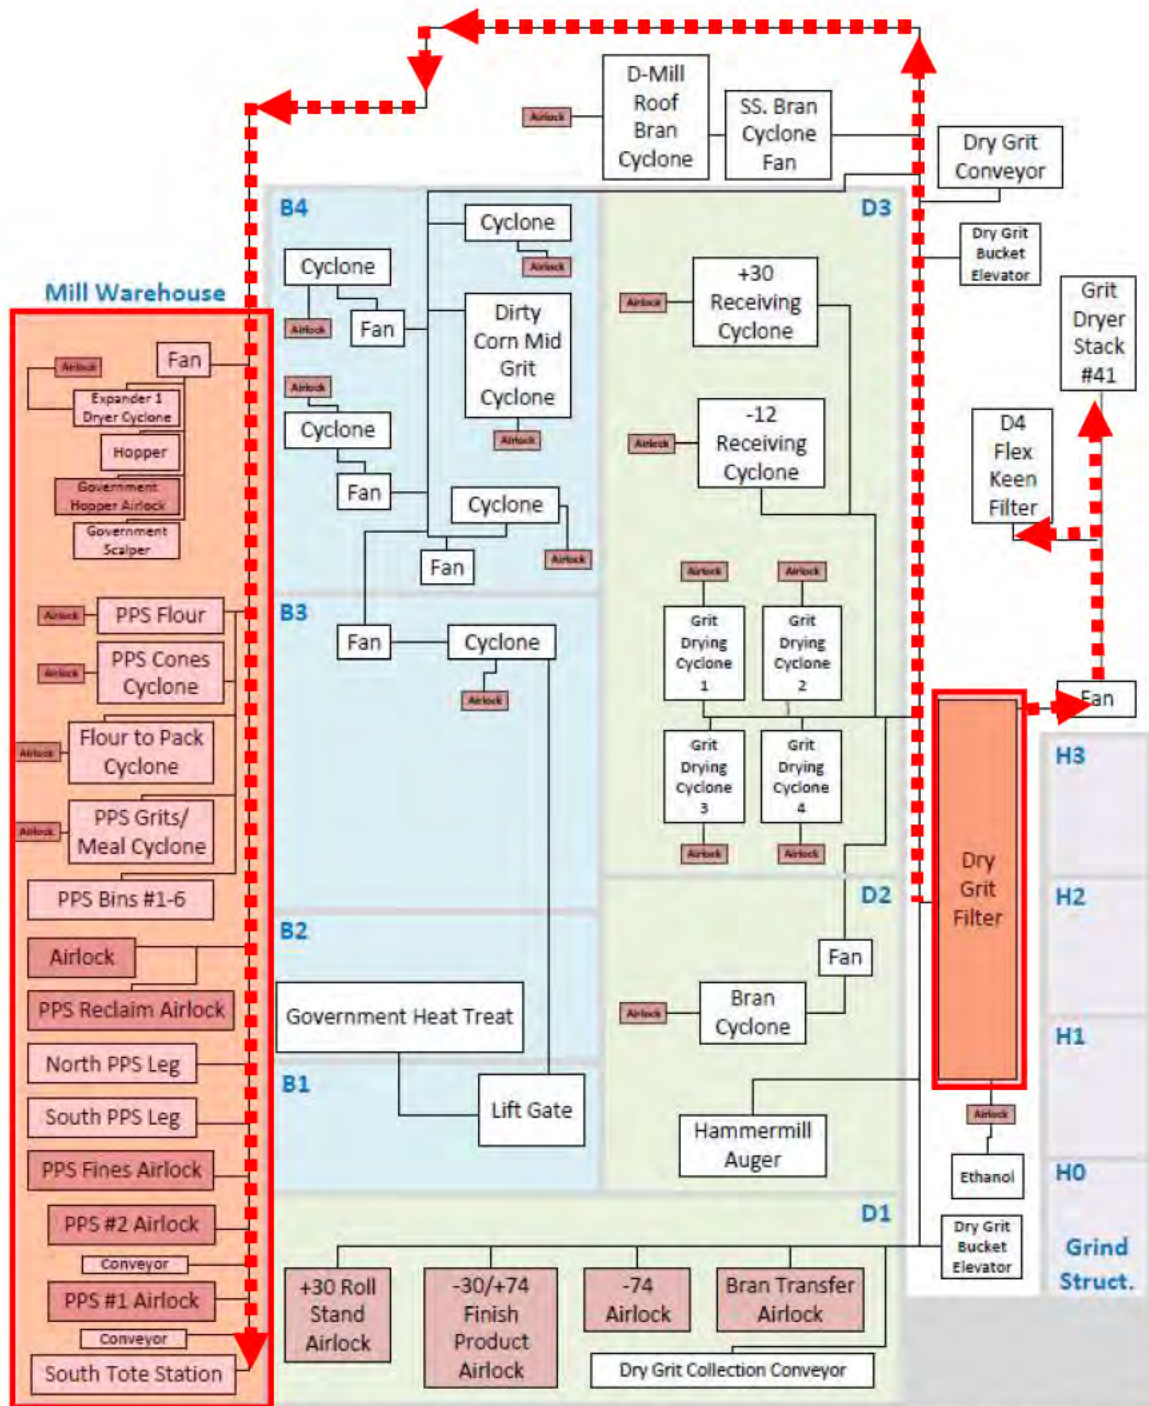
Figure 87. Dry Grit Filter to rest of Mill (Warehouse, B-Mill, D-Mill, and Grind Structure) with propagation shown in red.

As shown in the F6 Dry Grit Filter PFD,²⁰² the Dry Grit Filter spanned the D-Mill, B-Mill, and Warehouse in addition to the roof of the Grind Structure (also referred to as “Hammermill”). In the warehouse, the Dry Grit Filter was connected to multiple pieces of equipment in both the Pack area and the Product Protection System (PPS) area. While the warehouse was inaccessible after the incident, the PFDs show that this system was interconnected across multiple other areas of the mill through the Dry Grit Filter header. Due to the extent of damage and collapse in these areas, the extent of internal propagation into the Pack and PPS areas could not been determined, but it is likely that some amount of propagation occurred given the extensive evidence of propagation elsewhere in the Dry Grit Filter header.

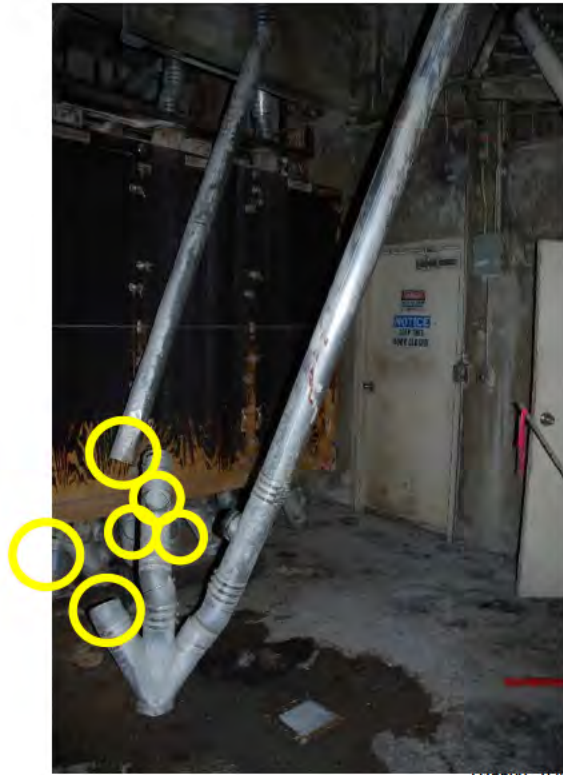
D16690-0281

Figure 88. Post-incident view of Grit/Flour Sifter (M-11021) on the 5th floor of the A-Mill.

Both of the sifters connected to the Dry Grit Filter in the A-Mill showed internal overpressure, observed from the caps blown off the bottom ducts from these pieces of equipment. These sifters fed into Reduction Roll Stands on A1, which fed the Sizing Flour 6-Section Sifter on the 3rd floor of the A-Mill, shown in Figure 90.

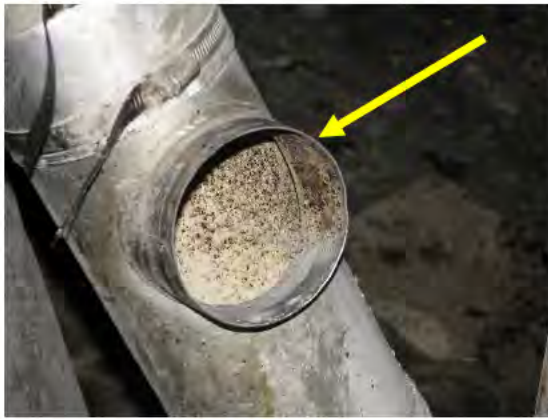
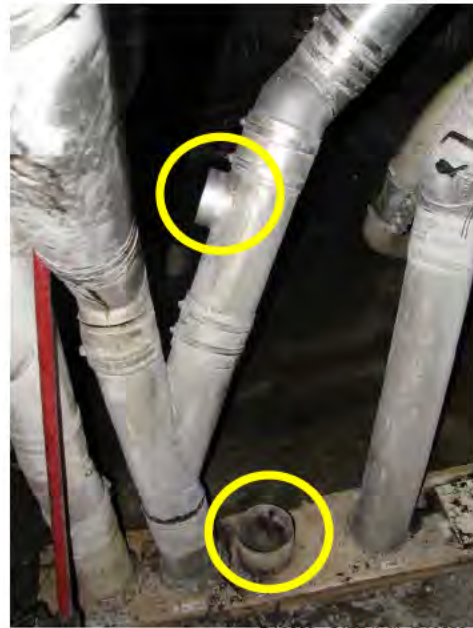
D16683 - 0177 (left), D16683 - 0181 (right)

In addition to the separated ducts from the internal overpressure experienced in the A-Mill, multiple locations showed burned grain deposited on the inside of the ducts, as can be seen in Figure 91. This is indicative of an internal overpressure inside the equipment propagating through the ducting as compared to an external overpressure event associated with fugitive dust within the building compartment.

Figure 92. Post-incident view of burned grain inside ducting in the A-Mill (2nd floor).

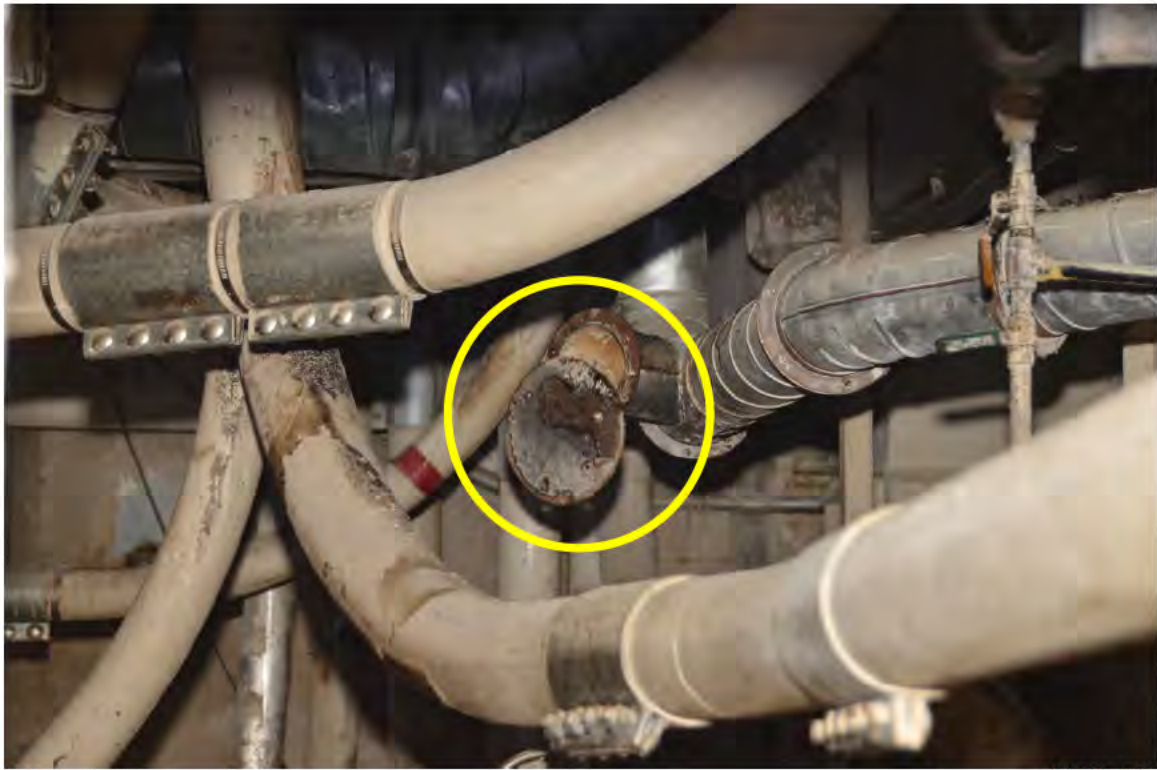
D16681 - 0044

Once in the ducting of the A-Mill, the flame propagation is shown to have spread through additional ducting in the photos below. Starting with the first floor of the A-Mill, additional ducts were observed to have experienced an internal overpressure and soot deposition from the grain fuel as shown in the separated blind in Figure 93.

Figure 93. Post-incident view of a separated flange in A1.

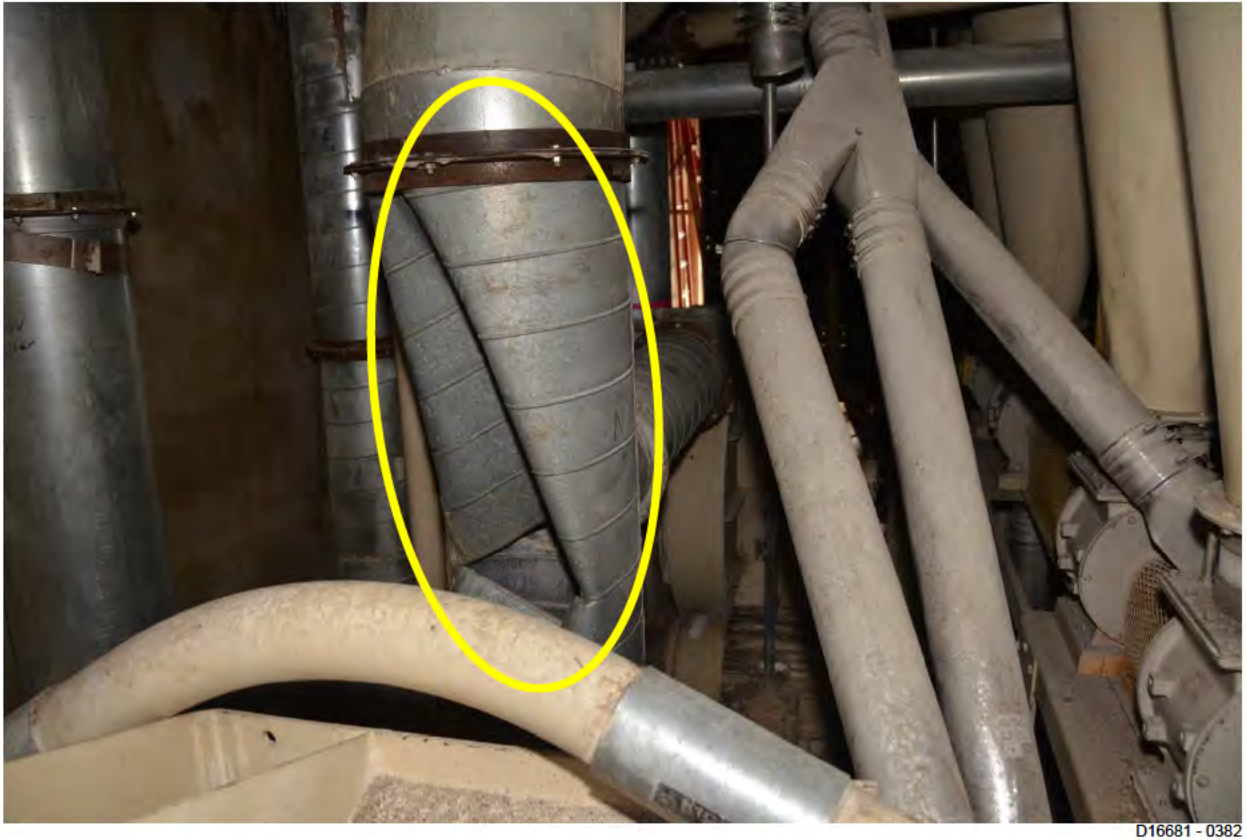
D16681 - 0382

Another apparently collapsed duct was also observed on the 4th floor of the A-Mill as shown in Figure 95. Additional separated ducting was also observed on the 4th floor of the A-Mill, shown in Figure 96.

Figure 95. Post-incident view of flattened duct from internal overpressure on the 4th floor of the A-Mill.

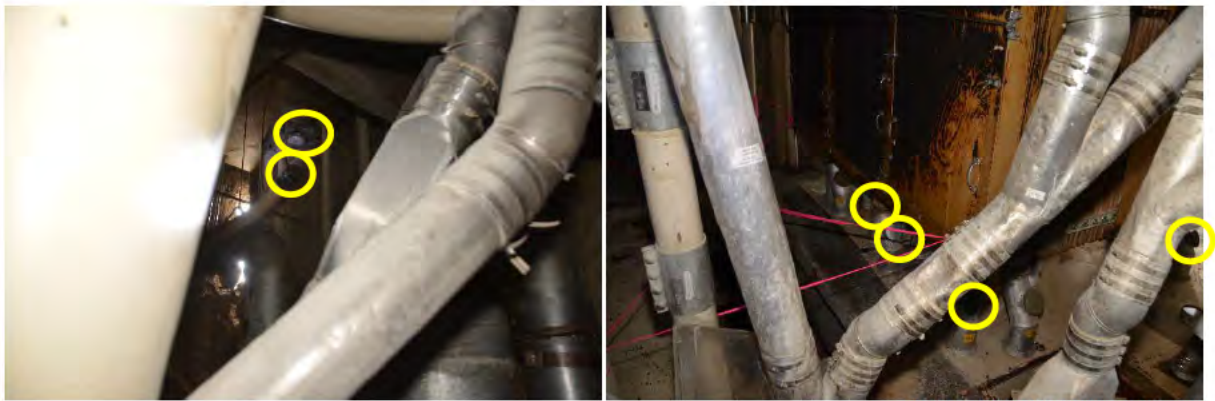
D16681 - 0399 (left), D16681 - 0404 (right)

Figure 96. Post-incident view of additional separated ducting on the 4th floor of the A-Mill.

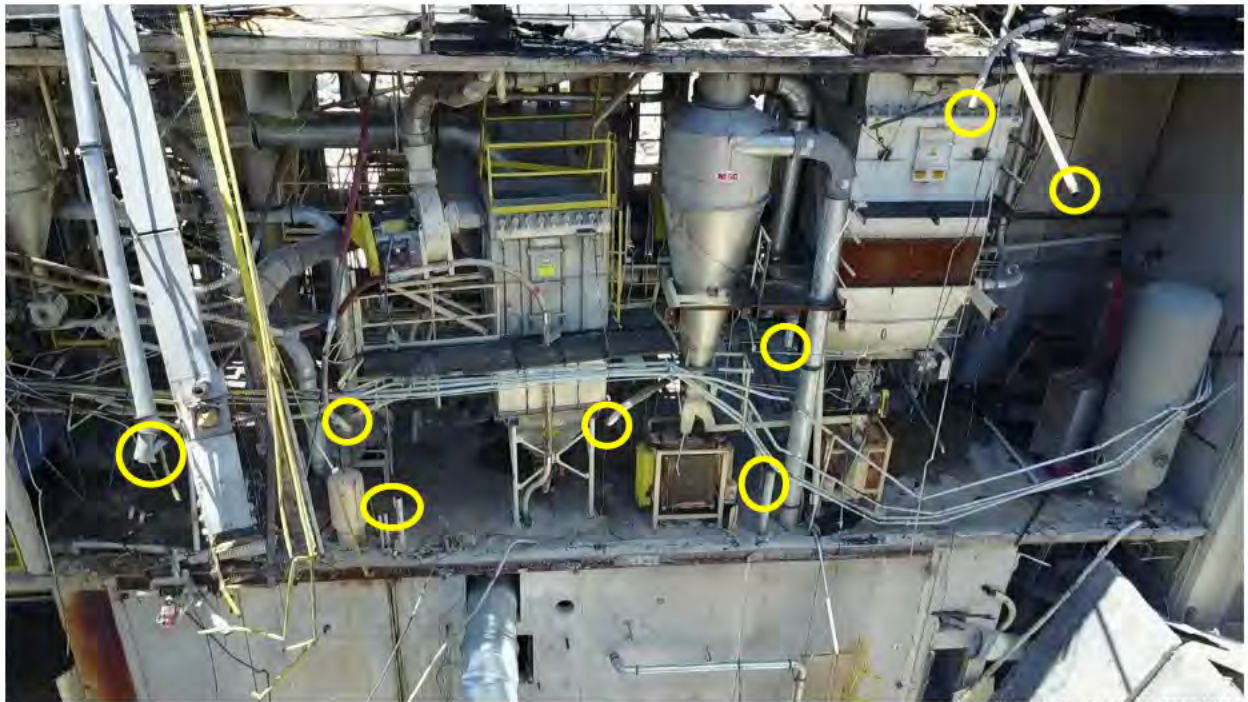
06-15-17 Drone Footage (DJI_0003 MOV)

While the Dry Grit Filter does not appear to have been connected directly to equipment in the Bran System in the B-Mill, it is connected to other systems inside the B-Mill such as the Government System,²⁰⁷ PPS fractionation system,^{208,209} and Grit Drying System.²¹⁰ Few photographs of the fourth floor of the B-Mill exist because it was considered unsafe for long-term occupation, but multiple ducts separated over the course of the incident, as observed in Figure 97.

Figure 97. Post-incident drone footage of the 4th floor of the B-Mill.

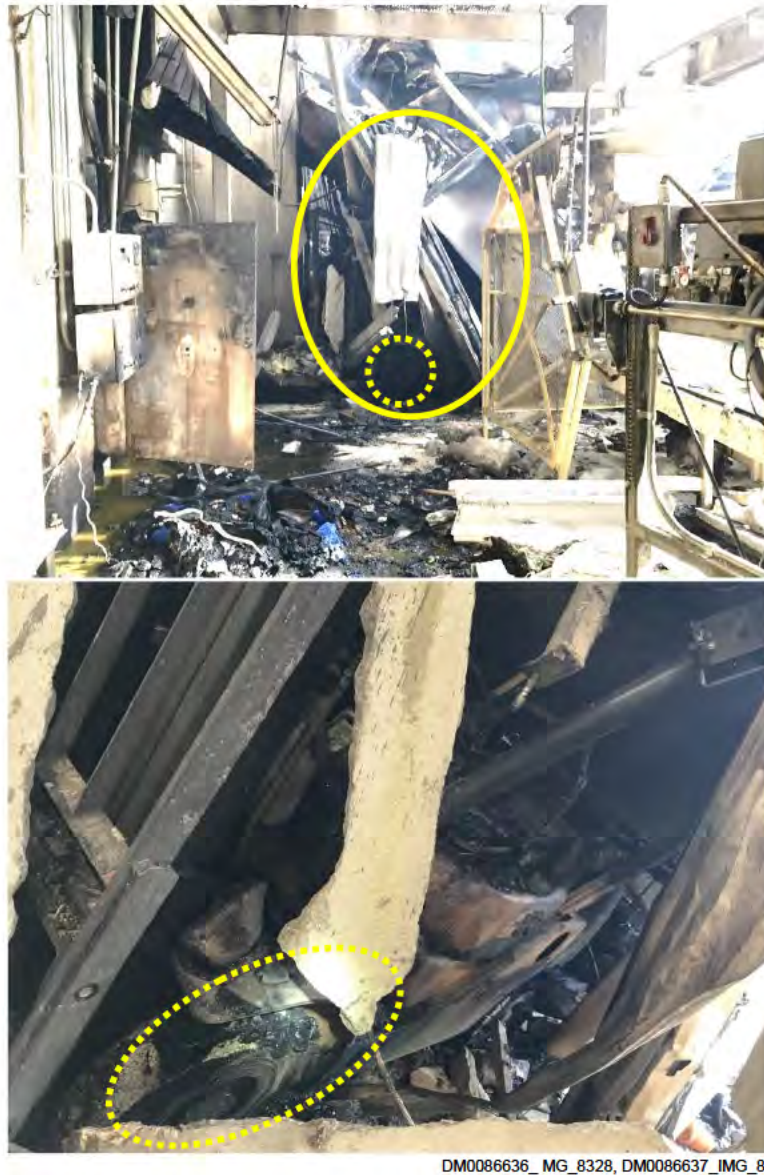
DM0086636_MG_8328, DM0086637_IMG_8330

During the incident, the LP-gas cylinder (PA EFI #49) associated with a fork truck (PA EFI #36) exploded in the Pack area. The fork truck was found very near the doorway into the Pack area from the stairwell between the A-mill and the B-mill. The LP-gas cylinder was apparently recovered further north near debris adjacent to the stairwell to the Pack mezzanine (see Figure 101).²¹¹ This is in the vicinity of the location where one of the decedents was found.²¹²

Figure 98. Photographs of the fork truck located in the Pack area most likely associated with the LP-gas explosion. The location of the fork truck is difficult to discern in the first photograph, due to lighting, so the front-left wheel has been circled in dashed yellow in each.

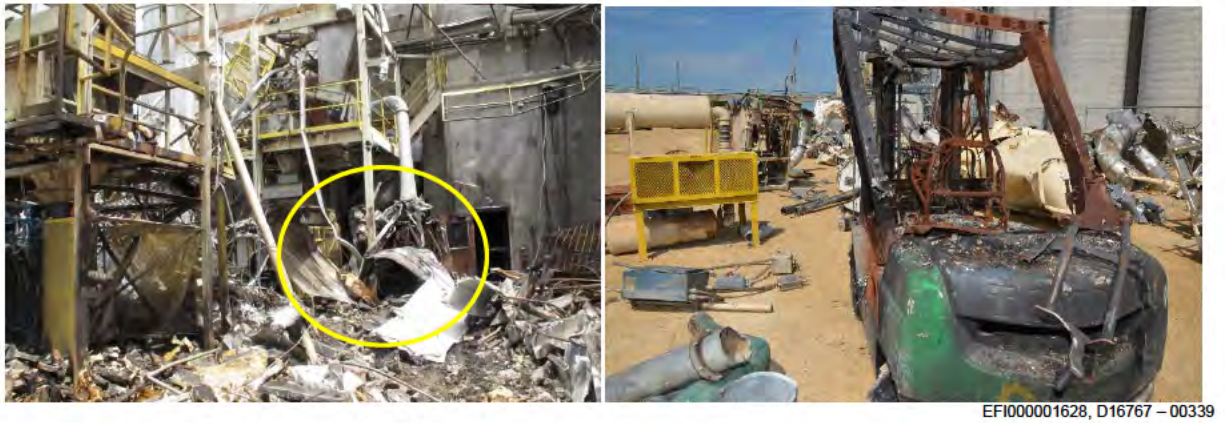
EF1000001628, D16767 – 00339

Figure 99. Photographs of the fork truck prior to recovery from the Pack area (left) and post recovery (right).

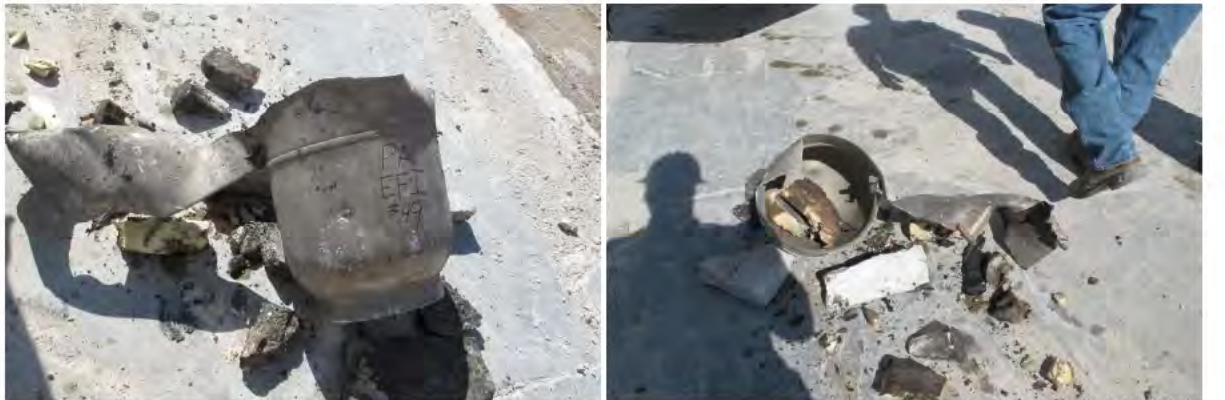
EF1000002689 (left) EF 000002690 (right)

Figure 100. The LP-gas cylinder most likely associated with the fork truck

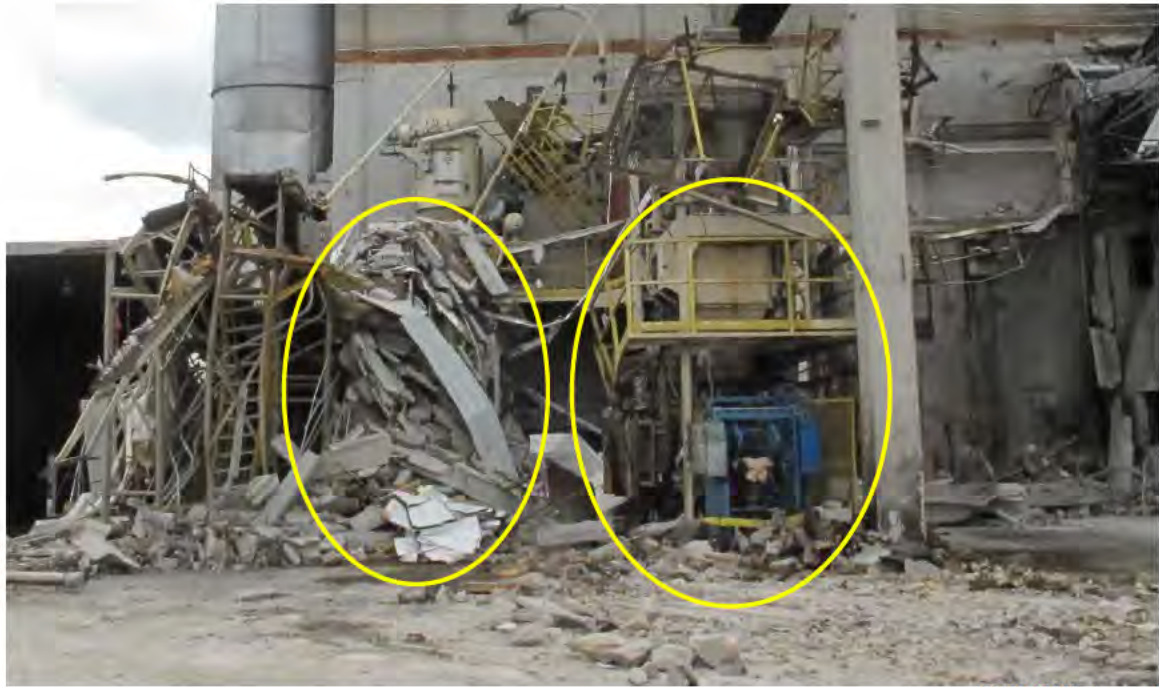
EF 000002626 (cropped)

Figure 101. The LP-gas cylinder was apparently recovered further north near debris adjacent to the stairwell to the Pack mezzanine, in the vicinity of a fan (PA EFI #47), the Pack line 2 scale filler and hanger (PA EFI #48), and an inclined conveyor associated with the Pack line (PA EFI #50). The fan and conveyor were located beneath the pile of debris circled on the left, and the location of the scale filler and hanger is circled on the right. One of the decedents was found under the debris shown on the left. See DM0086642_IMG_8337, showing both the fan and the conveyor, and DM0086643_IMG_8338, showing the decedent's as-found location under the stairwell to the mezzanine.

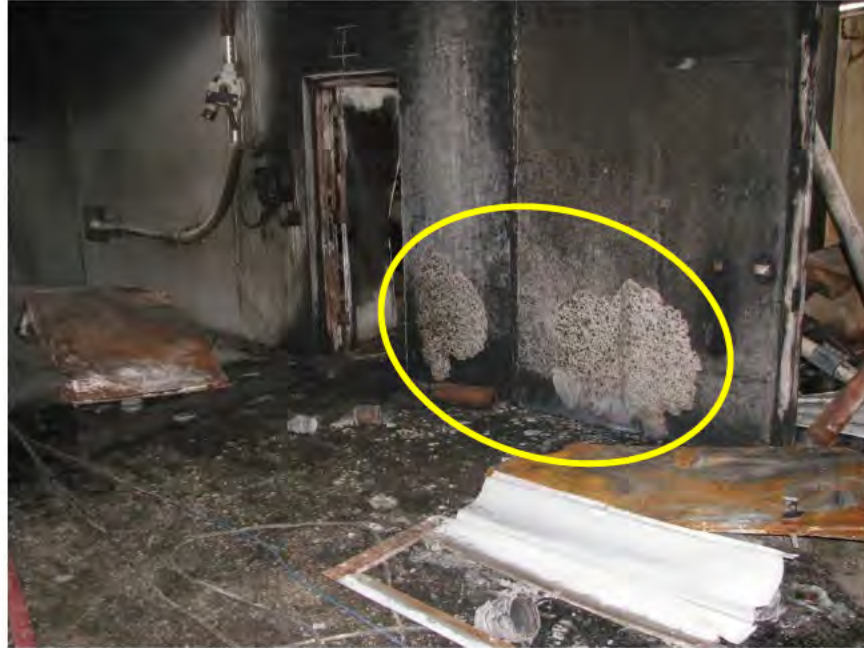
D16683 - 0025

A transformer was damaged by a panel that most likely fell from the B-Mill, resulting in a fire involving the mineral oil contents of the transformer. Burning liquid erupted and/or poured from the transformer into the Center Bay of the Truck Loadout area. The spalled concrete on the walls in the center bay is consistent with the rapid and intense heat development from an ignitable liquid fire.²¹³ The soot development on the walls and ceiling is consistent with a prolonged fire.

Figure 104. Center Bay looking at the doorway to the South Bay with the doorway to the transformer on the right. The spalled concrete walls, e.g., where the yellow circle encloses, are consistent with rapid and intense heat development from an ignitable liquid fire.²¹⁴

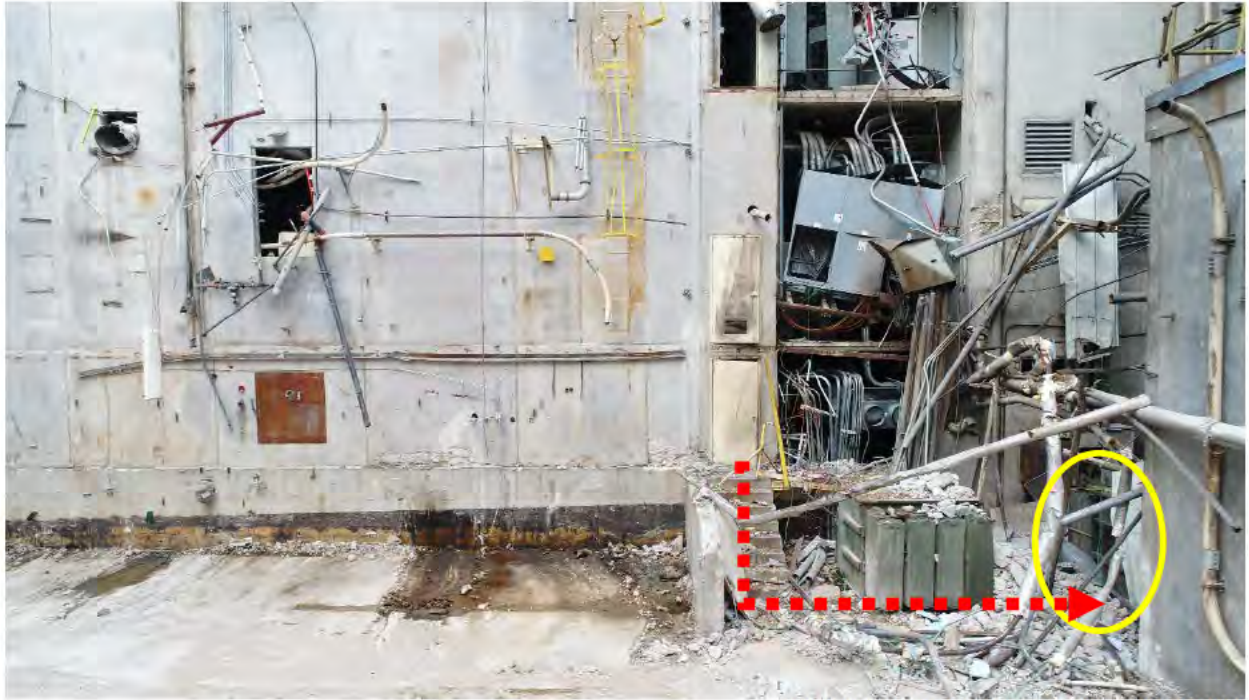
Client-supplied image from drone on October 2, 2017, DJI_0348

Figure 105. An egress pathway from B1 led up the internal North East stairs and back down into the transformer courtyard shown above, after the debris to the east of the B-Mill was cleared post-incident. From the transformer courtyard, the Center Bay was accessible through the double doorway in front of the transformer shown in Figure 103. The southern edge of this transformer can be seen in the far right, circled in yellow.

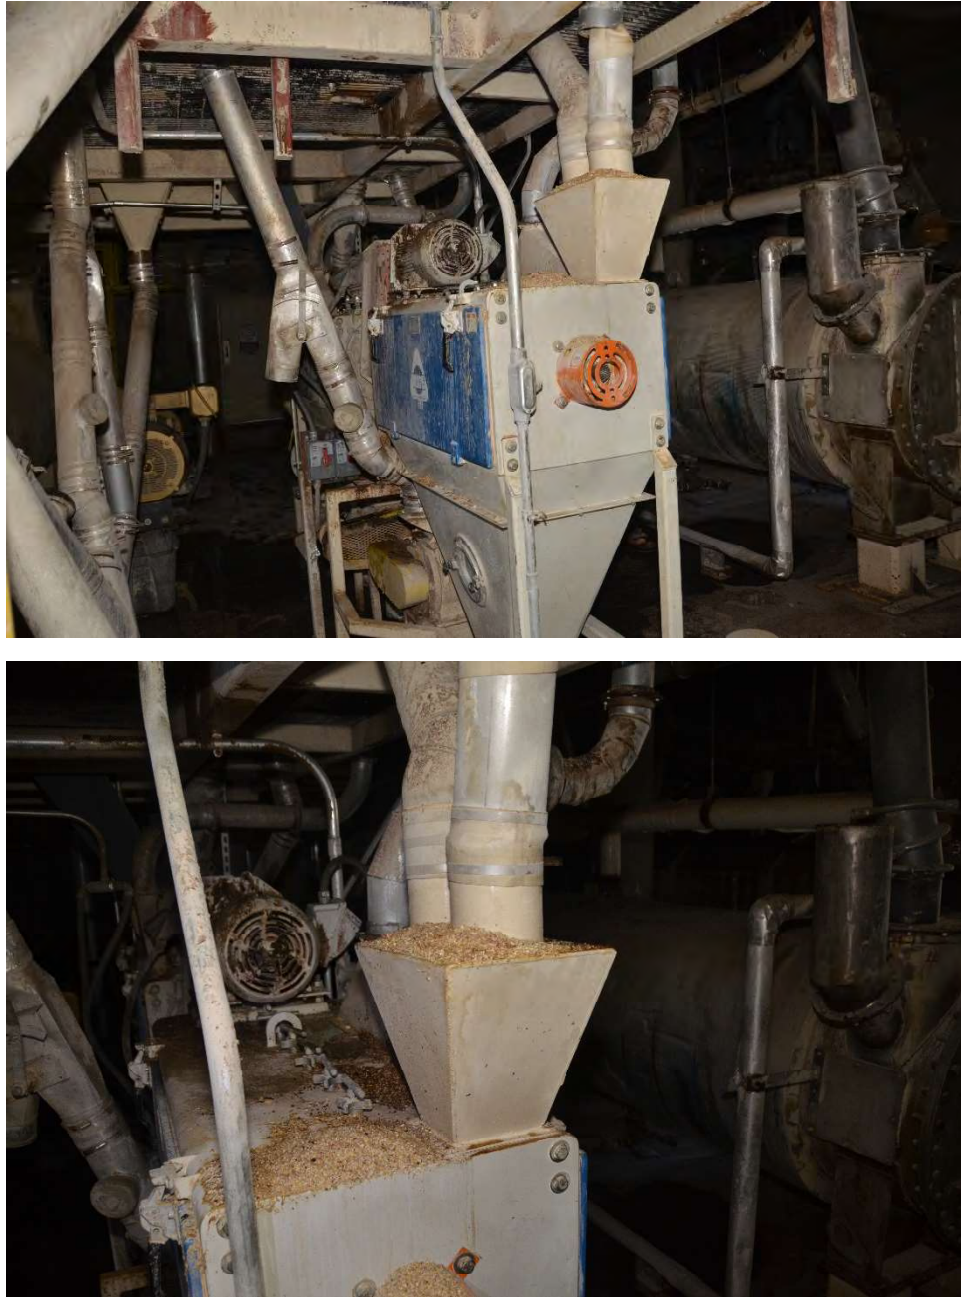
D16680 – 0602 (top), D16680 – 0627 (bottom)

Mr. Cholin states that approximately 0.066 m³ or about 12 feet of 6-inch duct would need to be filled with product to provide the fuel necessary for the explosion in B1. The combined volume of the two bran polishers (Figure 106) and the feed lines between them and the SBM would provide more than the amount that Mr. Cholin alleged was necessary. Furthermore, material would begin flowing rapidly as soon as an outlet pathway could be established (e.g., a duct is separated allowing unrestricted flow of material). The separated duct on the NBM inlet flowed directly from the 6-Section Sifter on 4B, which also would have provided considerably more material than would be contained in “12 feet of 6-inch duct.”

Figure 106. Photographs of one of two Bran Polishers immediately upstream of the South Bauermeister. Product clearly ejected and/or overflowed from the feed to each Bran Polisher.

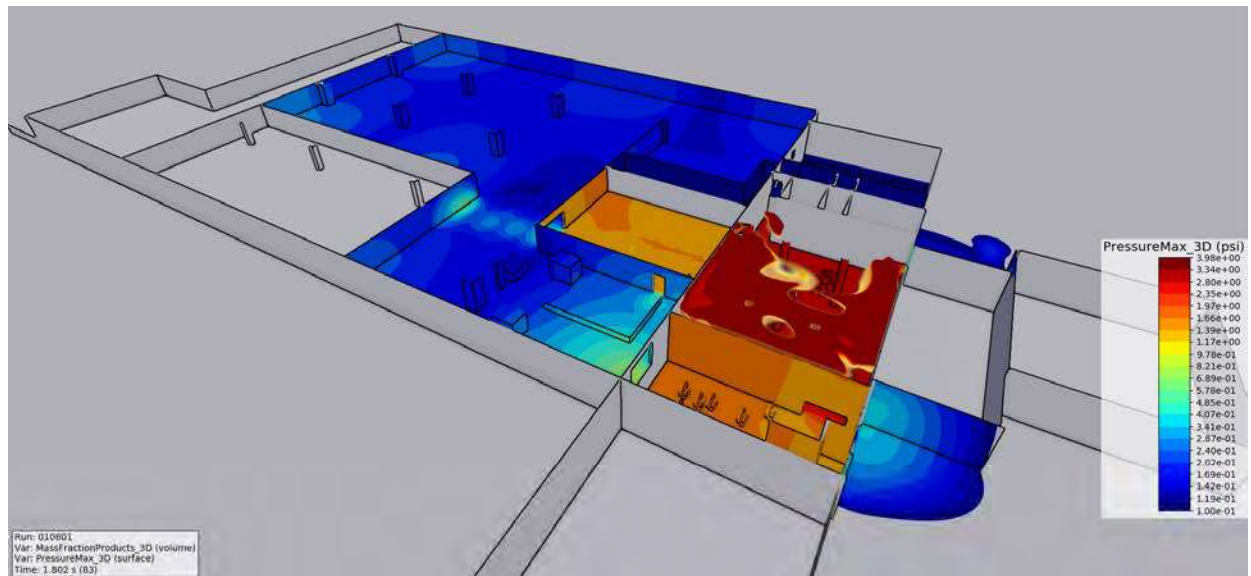
To model the explosion, a 3D map of the Didion Milling facility was generated using the mill drawings, photographs, and drone footage. The minimum grid size used was 7.9 inches (20 cm). Figure 107 shows the DustEx CFD model results overlaid onto a 3D map of the Didion Milling facilities. The results are shown with a cross-sectional cut just below the second level of the B-Mill, which cuts partially through the Warehouse height. The DustEx model was structured to provide a reasonable approximation of the pressures from a single ignition source within the B-Mill at the site of the Bauermeisters Grinder on the B1 Level. The failure pressures of man doors and roll-up doors were specified in consultation with structural engineers, who describe the basis in their report.

Figure 107. FLACS-DustEx CFD model results of the Didion Milling Facilities initiating on the 1st floor of the B-Mill. The results are only shown for the lower portion of the facility, even though the computational domain extends all the way to the top of the warehouse. The color contours indicate the maximum overpressures (in psi) experienced on surfaces. The deflagration extent at the end of the simulation (1.8 seconds after ignition) is shown in orange and red inside the 1st floor of the B-Mill.
